## Direction #209

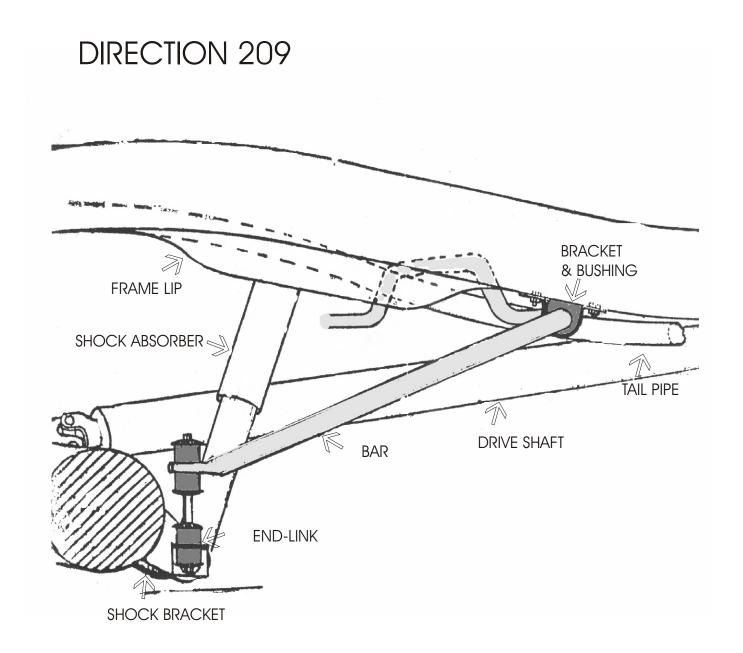
- Step #2. Place the mid-section bushings on the bar near the arm bends. Position the bar in front of the axle with the arms pointing backward and the dip (up) above the drive shaft and tailpipe(s) as shown.

- Step #3. Assemble the end-links as shown to connect the ends of the bar to the angle brackets. Tighten the end-link nuts just enough to slightly bulge the rubber bushings.

- Step #1. Remove the nuts from the lower shock bolts. In some cases, the stud bolts will have to be removed and installed so the bolt threads are toward the tires (outward). Position the angle brackets so that the 3/8" hole is on the stud bolt and the 5/8" hole is above the stud bolt. Replace the nuts and tighten to 25 lb/ft.

- Step #4. Raise the mid-section of the bar so that it contacts the frame. Move the mid-section bushings so that the flat side is against the frame. Move the bar forward or backward until the end-links are vertical from front to rear. Mark the frame for drilling. Drill the frame using a 3/8" drill bit.

- Step #5. Attach the frame bracket to the frame with the 3/8" bolts provided. Tighten the nuts to 25 lb/ft. Have someone bounce the vehicle to check for clearance of all parts throughout the suspension travel distance.
